**Flood Control Project Maintenance
Levee Inspections**

Fall 2019 Levee Maintenance Deficiency Summary Report

**Flood Control Project Maintenance
Levee Inspections****LMA District Cover Sheet****Fall 2019 Levee Inspection Results****Sacramento River West Side Levee District**

Sacramento River West Side Levee District

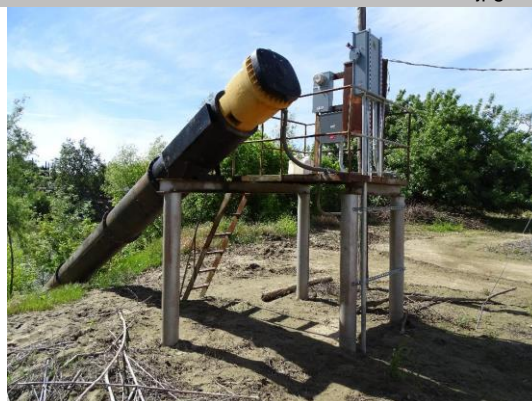
Photo 2 of 3 : UCIP_FA_2019_54223_79930.jpg

Slant pump on WS berm

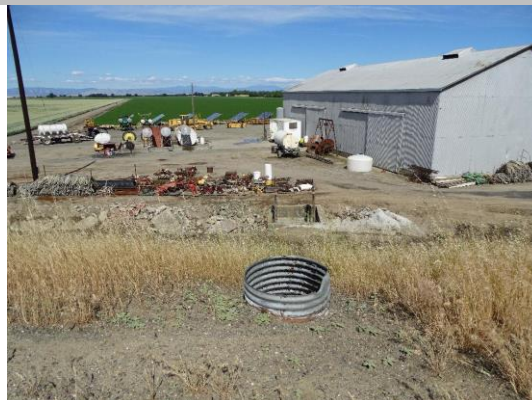
Photo 3 of 3 : UCIP_FA_2019_54223_79932.jpg

LS slope and CMP riser on LS shoulder

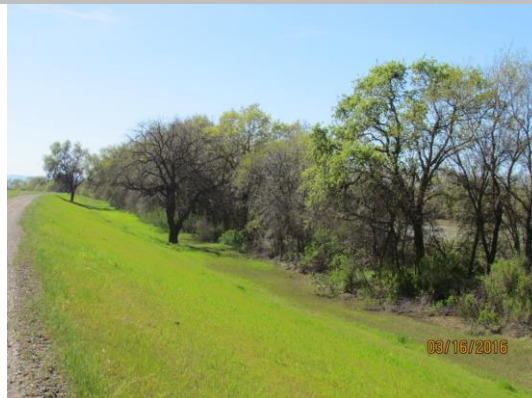
Photo 1 of 2 : FA_2019_NA0016_435_108_20190829_00041.jpg

LM Start	45.39	Rating **	A/W	Issue No.	108
LM End	45.90	Issue Type +	Ob	Location *	WS
Category	Earthen Levee			GPS Latitude/Longitude	
				Start	End
Item	Vegetation			39.192653°	39.188518°
				-121.952768°	-121.960446°
DWR ID	DWR_NA0016_01_s_2015_108				
Comment Code					
V8 : Environmental Requirements.					
Inspector Comment

View of the revegetation site on the waterward side of the levee looking upstream. Spring 2016.

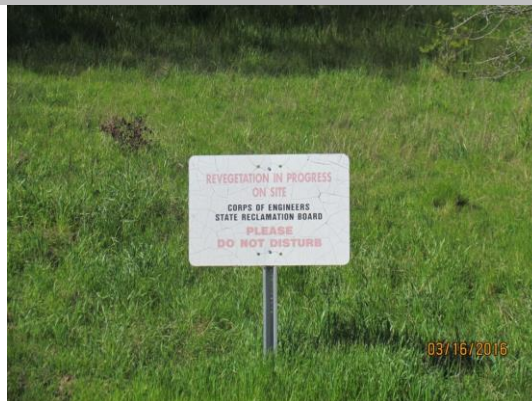
Photo 2 of 2 : FA_2019_NA0016_435_108_20190829_00042.jpg

Sign stating revegetation site. Spring 2016.

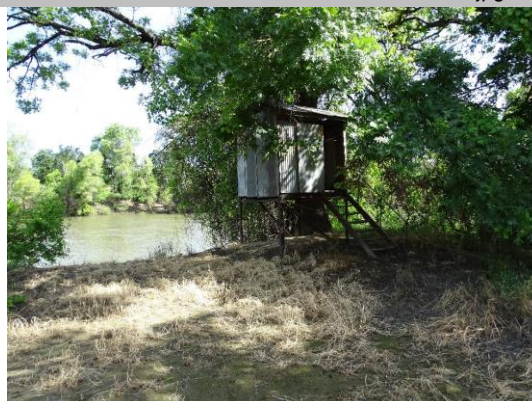
Photo 1 of 3 : UCIP_FA_2019_54224_79940.jpg

Comment Code					
Inspector Comment					
DS_ID:20294					
FS_ID:54224					
EP_NO: 9344					
Repair Type: Non-Urgent					
Crossing Status: Found					
UCIP Comments: 05/23/2019 Pump is connected via overhead electrical line. No issues recorded during inspection. (O.Yakimov - DWR UCIP)					
FIELD_STRUCT_DESC: 3 of 3: 24-inch steel irrigation pipe through the levee, 5.7 feet below the crown. Pump in pump house on the waterside (WS) bank. Gate valve inside the pump house. Discharges into an irrigation ditch on the landside (LS). (Automatic Board Order (ABO) issued as Permit No. 9344, 1974 - George E. Steidlmayer). [Additional Reference(s): DWR Levee Log, 2006. USACE Sacramento O&M Manual 131, May 1960 (HLM 46.06)].					
FS Date: 5/23/2019 2:00:17 PM

Old pumphouse on WS berm

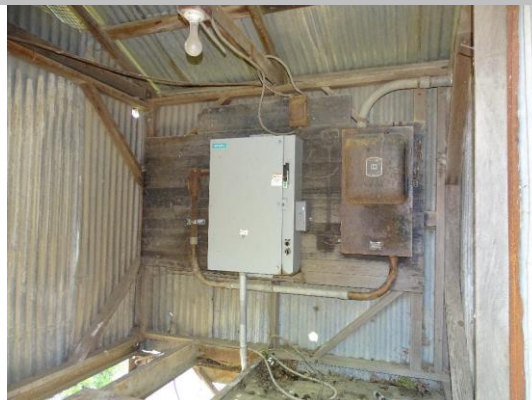
Photo 2 of 3 : UCIP_FA_2019_54224_79941.jpg

Electrical panels inside old pumphouse

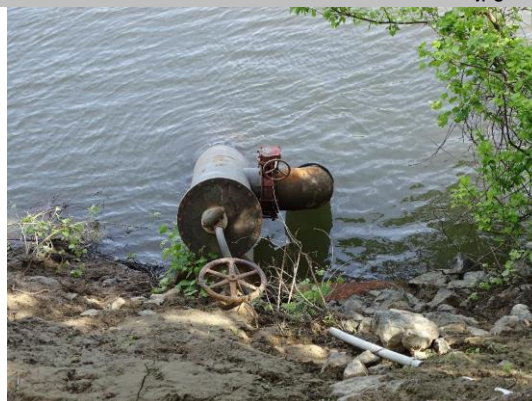
Photo 3 of 3 : UCIP_FA_2019_54224_79936.jpg

Intake pipe and shutoff valve at riverbank

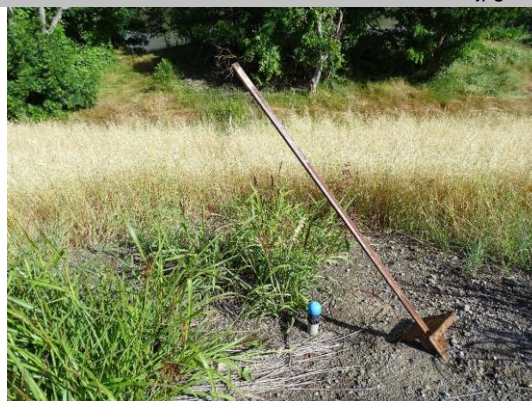
Photo 1 of 3 : UCIP_FA_2019_54225_79942.jpg

Comment Code						
Inspector Comment						
DS_ID:20314 FS_ID:54225 EP_NO: 15763 Repair Type: Non-Urgent Crossing Status: Found UCIP Comments: 05/23/2019 Found capped pipe at WS toe. (O.Yakimov - DWR UCIP)Fresno valve on WS shoulder is broken. Pipe appears to be abandoned. Need to abandon properly if necessary. site visit on 10/09/2015 indicates water is present somewhere along the waterside levee slope. Possibly siphon breaker or fresno valve sprays and drains down levee slope from WS shoulder. internal inspection of pipe recommended to determine source of leak. Pipe is active, but can be removed and capped when not in use. FIELD_STRUCT_DESC: 4-inch galvanized steel irrigation pipe through the levee, 2 feet below the crown. Irrigation valve approximately 50 feet landward of the landside (LS) toe. Fresno valve on the waterside (WS) shoulder with connection for pump at the WS berm. (Permit No. 15763, 1991 - Randy Salverson). FS Date: 5/23/2019 2:15:08 PM

Siphon breaker/air vent on WS shoulder and levee slope

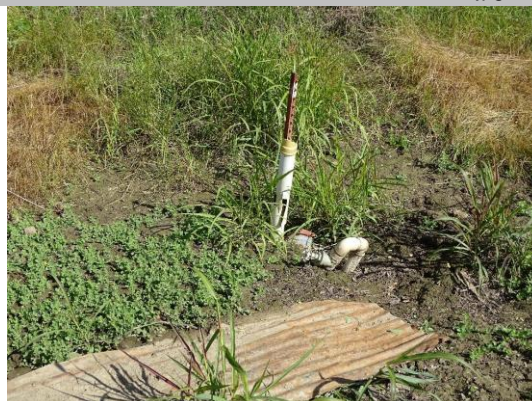
Photo 2 of 3 : UCIP_FA_2019_54225_79944.jpg

PVC line with shutoff valve and a capped pipe at WS toe

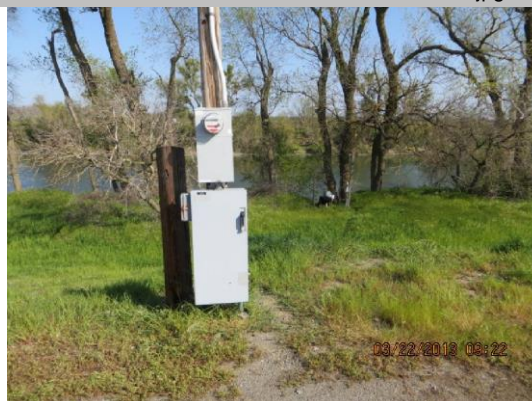
Photo 1 of 3 : UCIP_FA_2019_54226_17912.jpg

Comment Code						
Inspector Comment						
DS_ID:20295 FS_ID:54226 EP_NO: 9350 Repair Type: Non-Urgent Crossing Status: Found UCIP Comments: 05/23/2019 Erosion around concrete box at LS berm. (O.Yakimov - DWR UCIP) FIELD_STRUCT_DESC: 18-inch irrigation pipe of an unknown material through the levee, 21 feet below the crown. Gate valve and slant pump on the waterside (WS) bank. Switch board on the WS shoulder. Discharges into a 5-foot by 5-foot concrete distribution box on the landside (LS) toe. (Automatic Board Order (ABO) issued as Permit No. 9350, 1974 - W. H. Halsey). [Additional Reference(s): DWR Levee Log, 2006. USACE Sacramento O&M Manual 131, May 1960 (HLM 46.73)]. FS Date: 5/23/2019 2:34:30 PM

Electrical meter on LS shoulder and slant pump on WS berm.

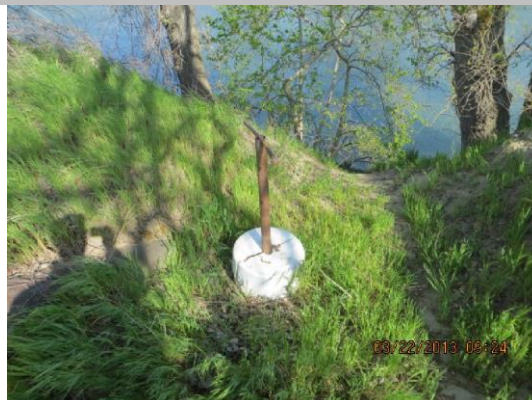
Photo 2 of 3 : UCIP_FA_2019_54226_17911.jpg

Valve on WS berm.

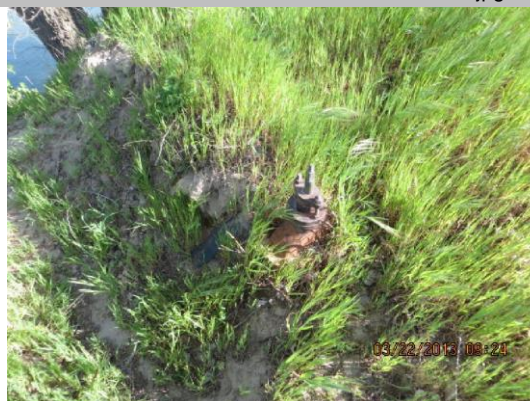
Photo 3 of 3 : UCIP_FA_2019_54226_17910.jpg

Slide gate on WS berm.

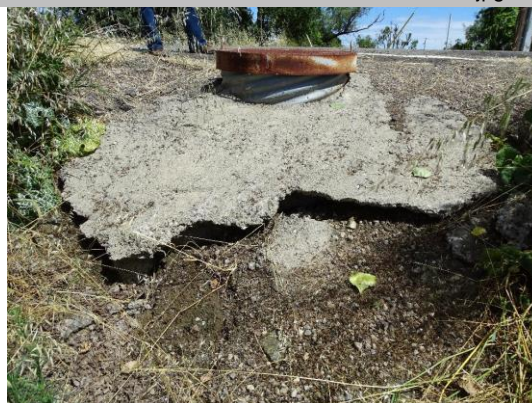
Photo 2 of 3 : UCIP_FA_2019_54227_79954.jpg

Item	DRAFT DWR UCIP Field Study			39.186111 °	39.186111 °	
				-121.968069 °	-121.968069 °	
DWR ID	20296					
Comment Code						
Inspector Comment						
DS_ID:20296 FS_ID:54227 EP_NO: 5551 Repair Type: Urgent Crossing Status: Found UCIP Comments: 05/23/2019 No visible changes to crossing status since last inspection. Pipe outlet is disconnected at LS toe which means that pipe not in use. (O.Yakimov - DWR UCIP)10/15/2018 Multiple cracks and points of depression on levee crown pavement (Moon Bend Rd). Sink hole on LS shoulder next to CMP riser. Voids around lower part of CMP riser concrete pad on LS shoulder. Condition of this crossing has worsen since last inspection. Recommend internal pipe inspection to determine pipe integrity through levee. (O.Yakimov - DWR)09/23/2016 - A second pipe is visible adjacent to the intake pipe. According to the permit drawings, this pipe is an access pipe for a submersible pump used to clean the fish screen by backwashing. hole on LS shoulder of the levee and Moon Bend Rd. has been patched. No additional road damage is visible. (T. Hatch/UCIP) 09/01/2016 no visible changes from previous inspection. - (T. Hatch/UCIP) 10/09/2015 Possible sink hole along alignment 10-feet LS of siphon breaker on LS slope. Recent road repair along the approximate pipe alignment suggests that levee slumping is related to pipe. It is recommended that further investigation e.g. video inspection or other internal method may help determine if the issue is due to pipe or due to levee settlement in vicinity of the pipe. (T. Hatch/UCIP) FIELD_STRUCT_DESC: 18-inch steel irrigation pipe through the levee, 3 feet below the crown. Pump mounted on a piling structure on the waterside (WS) bank. Switch box on the WS shoulder. Siphon breaker inside a 30-inch corrugated metal riser unit on the landside (LS) shoulder. Pipe discharges into a concrete box at the LS toe. (Automatic Board Order (ABO) issued as Permit No. 9349, 1974 - Ramona Davis). (Pump and pump platform replaced under Permit No. 5551, 1966 - Ramona Davis). (Fish screen installed under Permit No. 17222, 2000 - A&L Rental and Leasing). [Additional Reference(s): DWR Levee Log, 2006]. FS Date: 5/23/2019 7:56:57 AM

CMP riser on LS shoulder

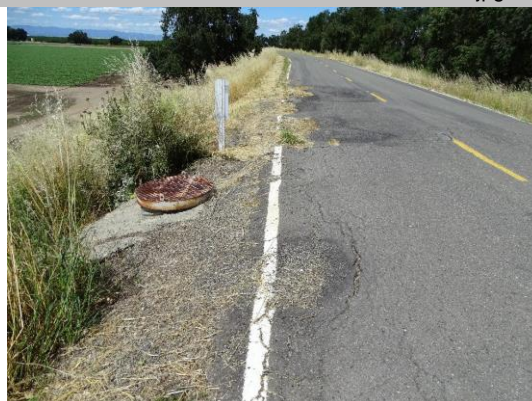
Photo 3 of 3 : UCIP_FA_2019_54227_79955.jpg

Multiple cracks and poits of depression on levee crown

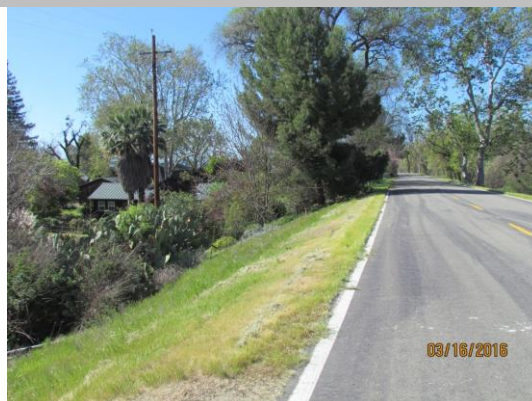
Photo 1 of 1 : FA_2019_NA0016_435_54_20190829_00017.jpg

LM Start	47.01	Rating **	M	Issue No.	54
LM End	47.14	Issue Type +	En	Location *	LS
Category	Earthen Levee			GPS Latitude/Longitude	
				Start	End
Item	Vegetation			39.188544 °	39.189733 °
				-121.979272 °	-121.981232 °
DWR ID	DWR_NA0016_01_s_2012_54				
Comment Code					
V6 : Landscaping					
Inspector Comment					
Cactus on slope and toe of levee, landscape continues along roadway with fence and stairs.

View of the landscaping on the landside slope. Spring 2016.

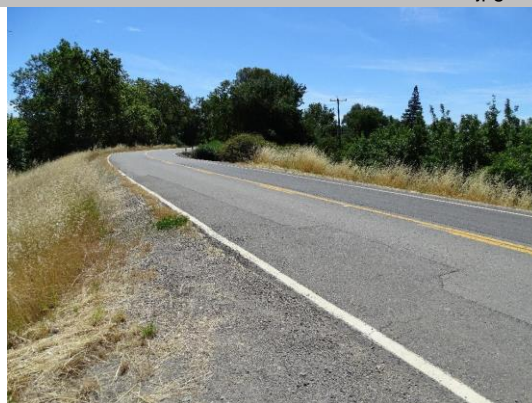
Photo 1 of 3 : UCIP_FA_2019_54230_79964.jpg

Comment Code						
Inspector Comment						
DS_ID:20298 FS_ID:54230 EP_NO: 9347 Repair Type: Non-Urgent Crossing Status: Indicator Found UCIP Comments: 05/23/2019 Concrete standpipe at LS toe not found. Repeat attempt when vegetation is cleared. (O.Yakimov - DWR UCIP)03/22/2013 Need to verify type of abandonment. FIELD_STRUCT_DESC: 1 of 2: 24-inch irrigation pipe of an unknown material through the levee, 25.5 feet below the crown. 14-inch pipe sleeved through 24-inch pipe. Annular space grouted. Pump inside pump house on the landside (LS). Gate valve inside pump house on the LS. (Automatic Board Order (ABO) issued as Permit No. 9347, 1974 - Floremon Orchards). [Additional Reference(s): DWR Levee Log, 2006. USACE Sacramento O&M Manual 131, May 1960 (HLM 47.71)]. FS Date: 5/23/2019 8:52:46 AM

Levee crown at crossing

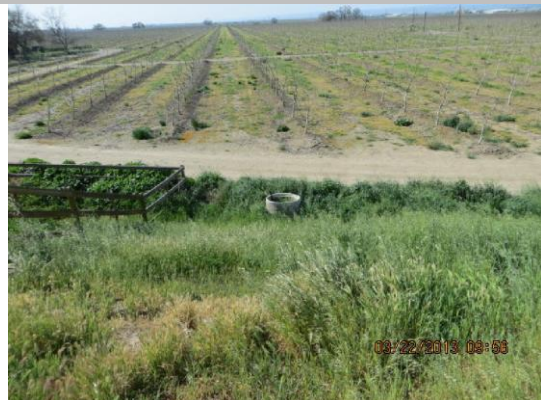
Photo 3 of 3 : UCIP_FA_2019_54230_17929.jpg

Possible location for pipe crossing

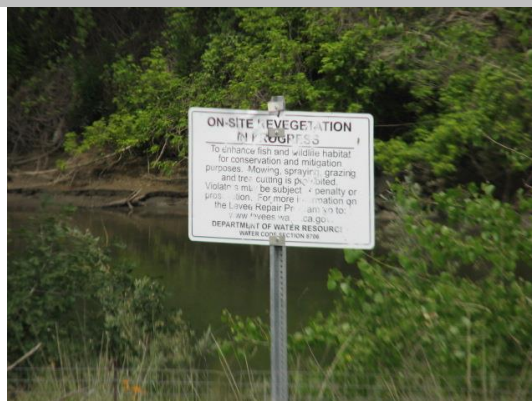
Photo 1 of 1 : FA_2019_NA0016_435_90_20190829_00028.jpg

LM Start	47.19	Rating **	A/W	Issue No.	90
LM End	47.62	Issue Type +	Ob	Location *	WS
Category	Earthen Levee			GPS Latitude/Longitude	
				Start	End
Item	Vegetation			39.189930 °	39.193491 °
				-121.982143 °	-121.988184 °
DWR ID	DWR_NA0016_01_s_2014_90				
Comment Code					
V8 : Environmental Requirements.					
Inspector Comment

A revegetation site along the waterside berm. Spring 2014

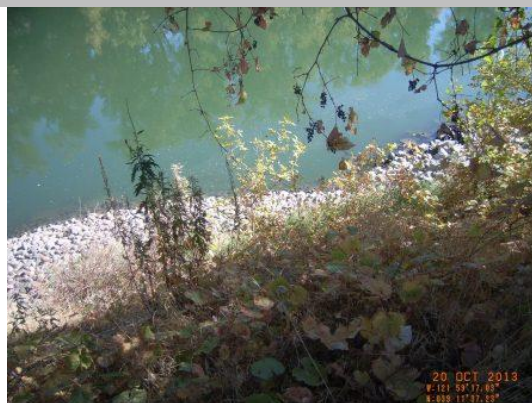
Photo 1 of 1 : FA_2019_NA0016_435_97_20190829_00035.jpg

LM Start	47.62	Rating **	A/W	Issue No.	97
LM End	47.77	Issue Type +	Ma	Location *	WS
Category	Supplemental			GPS Latitude/Longitude	
				Start	End
Item	2017 USACE Erosion Survey			39.193769 °	39.195595 °
				-121.987901 °	-121.988621 °
DWR ID	DWR_NA0016_01_f_2018_97				
Comment Code					
Inspector Comment					
2017 Site ID: SAC 141.5 R					
Status: Eroding					
2017 Field Notes: No observed change.					
Site History: 2010 - Old cobble site starting to unravel at toe. 2011 - Cobbles continue to unravel. 2013 - Site extended downstream to revetment.

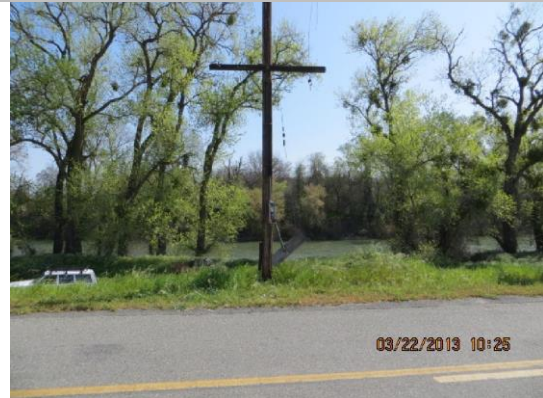
Photo 1 of 3 : UCIP_FA_2019_54231_17940.jpg

Comment Code						
Inspector Comment						
DS_ID:20309 FS_ID:54231 EP_NO: 9347 Repair Type: Non-Urgent Crossing Status: Indicator Found UCIP Comments: 05/23/2019 Pipe not visible on any of levee sides. Power line is disconnected from junction pole. Electric box at JP is disrupted. Confirm pipe removal. (O.Yakimov - DWR UCIP)03/22/2013 Need to determine type of abandonment. FIELD_STRUCT_DESC: *REMOVED* 2 of 2: 16-inch steel irrigation pipe through the levee, 17.3 feet below the crown. Gate valve on the waterside (WS) end. Pump on the WS bank. Switch box on the WS shoulder. (Automatic Board Order (ABO) issued as Permit No. 9347, 1974 - Floremon Orchards). [Additional Reference(s): DWR Levee Log, 1980. USACE Sacramento O&M Manual 131, May 1960 (HLM 48.23)]. FS Date: 5/23/2019

JP on WS shoulder for removed pump switch house.

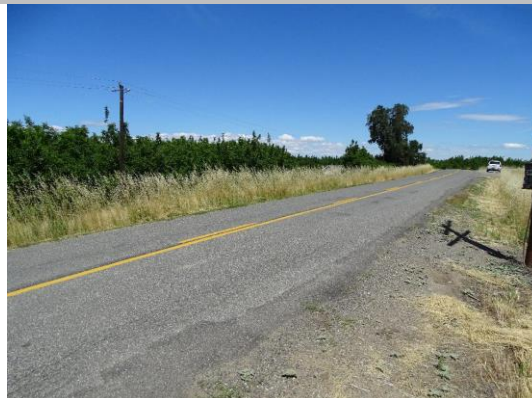
Photo 3 of 3 : UCIP_FA_2019_54231_79966.jpg

Levee crown at crossing

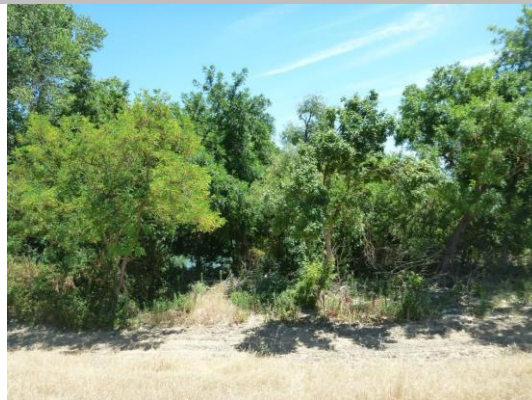
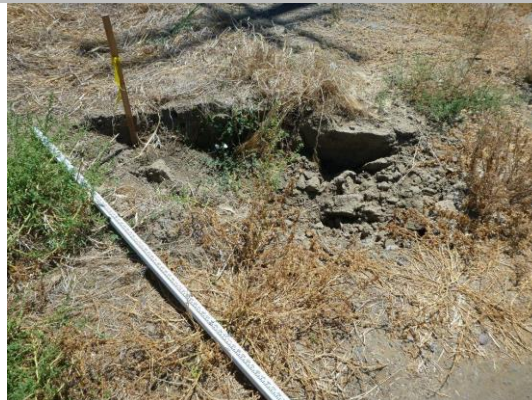
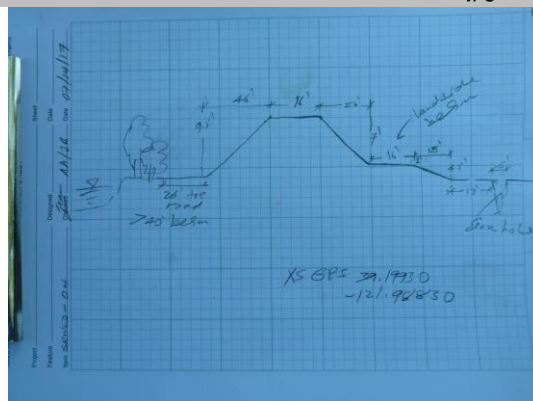
LM Start	47.96	Rating **	A/W	Issue No.	127
LM End	48.03	Issue Type +	Ob	Location *	
Category	Supplemental			GPS Latitude/Longitude	
				Start	End
Item	2017 Storm Damage			39.198380 °	39.199330 °
				-121.988603 °	-121.988197 °
DWR ID	SRWLD-04				
Comment Code					
Inspector Comment					
Levee Evaluation Comments					
Description:					
Site ID No:186					
Site Designation:SRWLD-04					
Repair Type: Seepage					
Rating:Serious					
Field Date:7/14/2017					
Notes: Berm will be constructed in 2020.

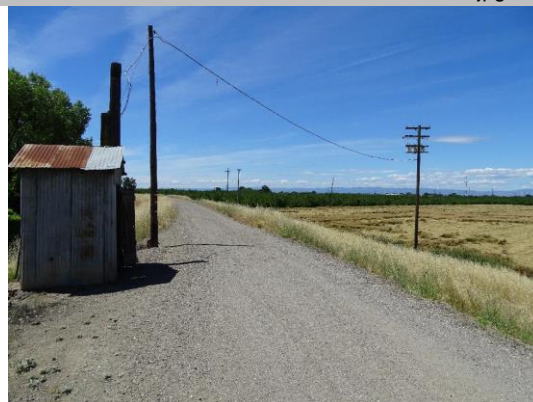
Photo 1 of 3 : UCIP_FA_2019_54232_79969.jpg

Comment Code						
Inspector Comment						
DS_ID:20299						
FS_ID:54232						
EP_NO: 9343						
Repair Type: Non-Urgent						
Crossing Status: Found						
UCIP Comments: 05/23/2019 Crossing looks abandoned. (O.Yakimov - DWR UCIP)						
FIELD_STRUCT_DESC: 1 of 2: 14-inch steel irrigation pipe through the levee, 17.7 feet below the crown. Switch house on the waterside (WS) shoulder. Slant pump and gate valve on the WS bank. Flow meter inside a 14-inch steel standpipe on the landside (LS) toe. Fresno valve inside a 10-inch steel standpipe on the LS toe. Overhead power line crosses the levee. Poles and anchor on the WS slope. (Automatic Board Order (ABO) issued as Permit No. 9343, 1974 - Emile F. Cribari). [Additional Reference(s): DWR Levee Log, 2006. USACE Sacramento O&M Manual 131, May 1960 (HLM 48.64)].						
FS Date: 5/23/2019 11:06:16 AM

Levee crown at crossing

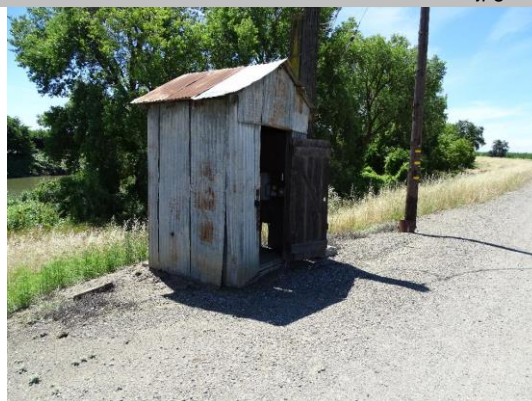
Photo 2 of 3 : UCIP_FA_2019_54232_79971.jpg

Abandoned switch house on WS sholder

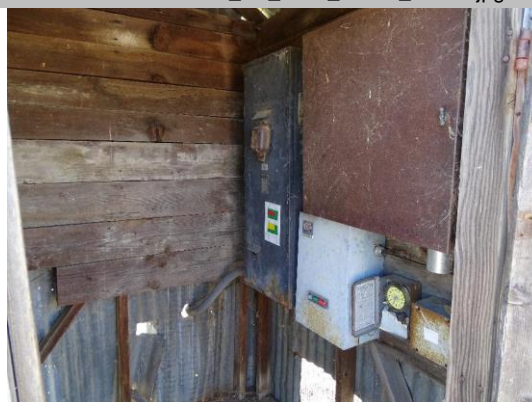
Photo 3 of 3 : UCIP_FA_2019_54232_79972.jpg

View inside of switch house

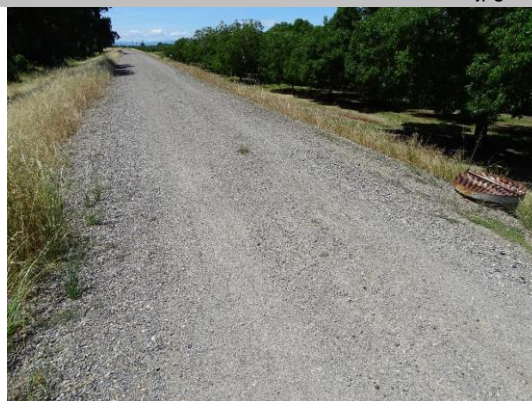
Photo 1 of 3 : UCIP_FA_2019_54233_79977.jpg

Comment Code						
Inspector Comment						
DS_ID:20300 FS_ID:54233 EP_NO: 9343 Repair Type: Non-Urgent Crossing Status: Found UCIP Comments: 05/23/2019 Spot of green grass at pipe alignment is noticeable on WS slope. Pump on WS berm is covered with brush and not accessible. (O.Yakimov - DWR UCIP)03/22/2013 Pipe appears to be abandoned. Need to verify type of abandonment. FIELD_STRUCT_DESC: 2 of 2: 24-inch irrigation pipe of an unknown material through the levee, 15.5 feet below the crown. (Pipe measures 12 inches on landside (LS) toe). Slant pump on steel piling structure on the waterside (WS) bank. Butterfly valve at the LS toe. Overhead power line crosses the levee. (Automatic Board Order (ABO) issued as Permit No. 9343, 1974 - Emile F. Cribari). [Additional Reference(s): DWR Levee Log, 2006. USACE Sacramento O&M Manual 131, May 1960 (HLM 48.91)]. FS Date: 5/23/2019 11:42:24 AM

Levee crown at crossing

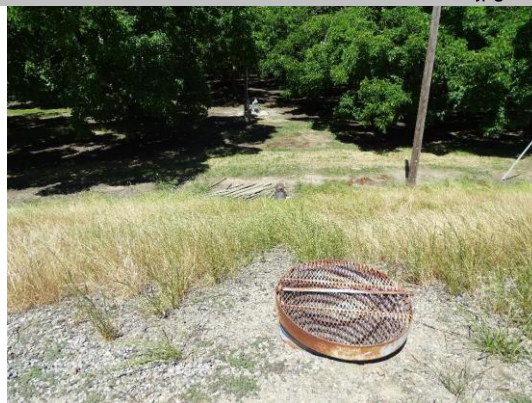
Photo 2 of 3 : UCIP_FA_2019_54233_79978.jpg

Siphon breaker in 30-inch CMP riser on LS shoulder

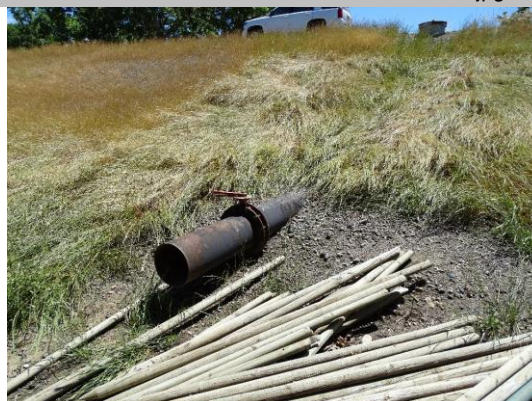
Photo 3 of 3 : UCIP_FA_2019_54233_79979.jpg

Pipe with a butterfly valve at LS toe

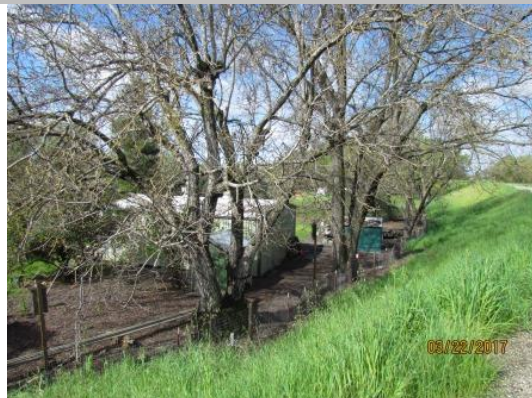
Photo 1 of 1 : FA_2019_NA0016_435_199_20190829_00067.jpg

LM Start	48.58	Rating **	M	Issue No.	199
LM End	49.58	Issue Type +	En	Location *	LS
Category	Earthen Levee			GPS Latitude/Longitude	
				Start	End
Item	Encroachments			39.206495 °	39.213650 °
				-121.984426 °	-121.999883 °
DWR ID	DWR_NA0016_01_s_2017_199				
Comment Code					
FE : Fence					
Inspector Comment					
A fence is along the landside levee toe blocking access.

View of fence along landside levee toe. Spring 2017.

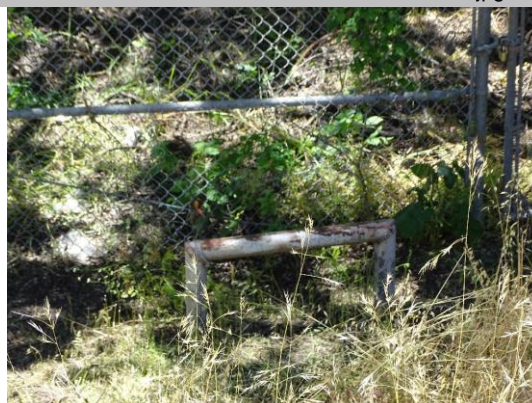
Photo 1 of 3 : UCIP_FA_2019_54235_79981.jpg

LM Start	48.68	Rating **	M	Issue No.	1684
LM End	48.68	Issue Type +	En	Location *	
Category	Supplemental			GPS Latitude/Longitude	
				Start	End
Item	DRAFT DWR UCIP Field Study			39.207294 °	39.207294 °
				-121.985903 °	-121.985903 °
DWR ID	20352				
Comment Code					
Inspector Comment					
DS_ID:20352 FS_ID:54235 EP_NO: N/A Repair Type: Non-Urgent Crossing Status: Indicator Found UCIP Comments: 05/23/2019 Pipe not found. Confirm pipe removal or abandonment. (O.Yakimov - DWR UCIP) FIELD_STRUCT_DESC: 2 of 2: 7-inch petroleum pipeline of an unknown material through the levee, 2.6 feet below the crown. Metal support for pipe at landside (LS) toe near Shell Oil Co. property edge. Appears to be abandoned. [Additional Reference(s): USACE Sacramento O&M Manual 131, May 1960 (HLM 49.22)]. FS Date: 5/23/2019 11:53:44 AM

Pipe support structure at LS toe

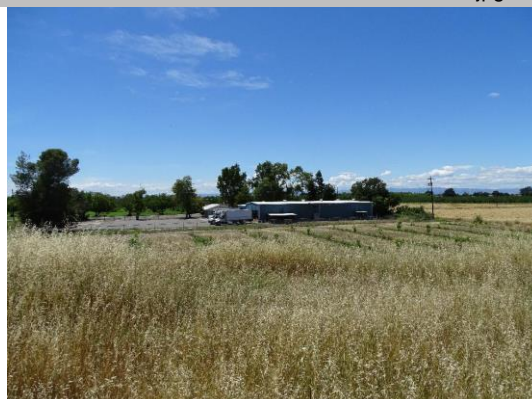
Photo 2 of 3 : UCIP_FA_2019_54235_79982.jpg

LM Start	48.68	Rating **	M	Issue No.	1684 (cont)
LM End	48.68	Issue Type +	En	Location *	
Category	Supplemental			GPS Latitude/Longitude	
				Start	End
Item	DRAFT DWR UCIP Field Study			39.207294 °	39.207294 °
				-121.985903 °	-121.985903 °
DWR ID	20352				
Comment Code					
Inspector Comment					
DS_ID:20352 FS_ID:54235 EP_NO: N/A Repair Type: Non-Urgent Crossing Status: Indicator Found UCIP Comments: 05/23/2019 Pipe not found. Confirm pipe removal or abandonment. (O.Yakimov - DWR UCIP) FIELD_STRUCT_DESC: 2 of 2: 7-inch petroleum pipeline of an unknown material through the levee, 2.6 feet below the crown. Metal support for pipe at landside (LS) toe near Shell Oil Co. property edge. Appears to be abandoned. [Additional Reference(s): USACE Sacramento O&M Manual 131, May 1960 (HLM 49.22)]. FS Date: 5/23/2019 11:53:44 AM

Property/yard at LS toe that could have belonged to Shell

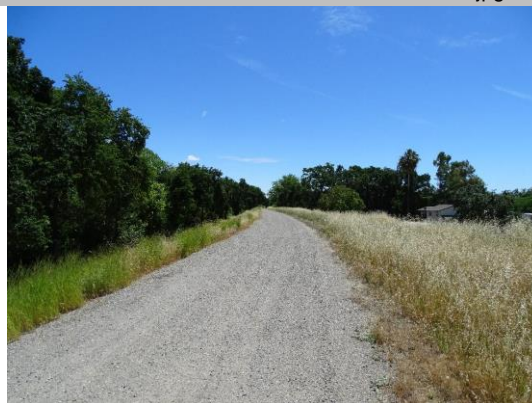
Photo 3 of 3 : UCIP_FA_2019_54235_79983.jpg

Levee crown at crossing

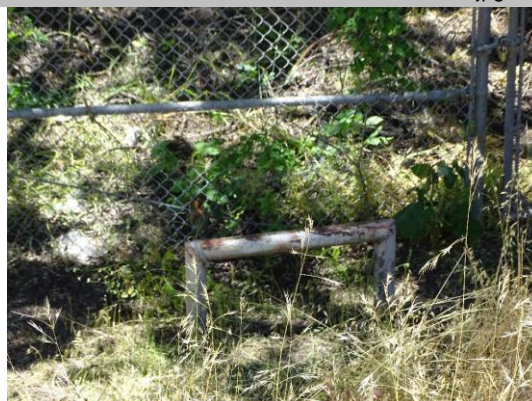
Photo 1 of 3 : UCIP_FA_2019_54236_79984.jpg

LM Start	48.68	Rating **	M	Issue No.	1685
LM End	48.68	Issue Type +	En	Location *	
Category	Supplemental			GPS Latitude/Longitude	
				Start	End
Item	DRAFT DWR UCIP Field Study			39.207294 °	39.207294 °
				-121.985903 °	-121.985903 °
DWR ID	20407				
Comment Code					
Inspector Comment					
DS_ID:20407 FS_ID:54236 EP_NO: N/A Repair Type: Non-Urgent Crossing Status: Indicator Found UCIP Comments: 05/23/2019 Pipe not found. Confirm pipe removal or abandonment. (O.Yakimov - DWR UCIP) FIELD_STRUCT_DESC: 1 of 2: 7-inch oil pipeline of an unknown material through the levee, 2.6 feet below the crown. Metal support for pipe found at landside (LS) toe near Shell Oil Co. property edge. Appears to be abandoned. [Additional Reference(s): USACE Sacramento O&M Manual 131, May 1960 (HLM 49.22)]. FS Date: 5/23/2019 2:02:32 PM

Pipe support structure at LS toe

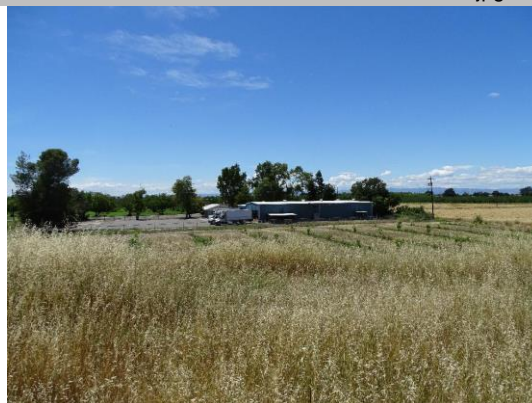
Photo 2 of 3 : UCIP_FA_2019_54236_79985.jpg

Property/yard at LS toe that could have belonged to Shell

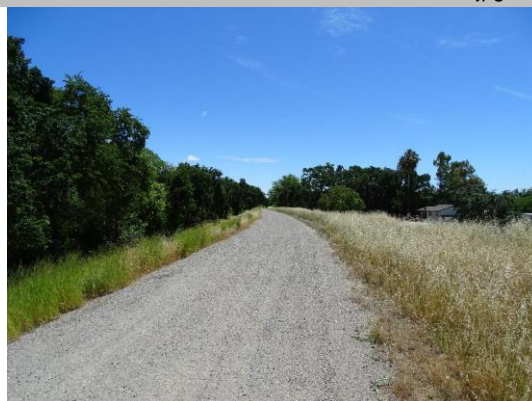
Photo 3 of 3 : UCIP_FA_2019_54236_79986.jpg

LM Start	48.68	Rating **	M	Issue No.	1685 (cont)
LM End	48.68	Issue Type +	En	Location *	
Category	Supplemental			GPS Latitude/Longitude	
				Start	End
Item	DRAFT DWR UCIP Field Study			39.207294 °	39.207294 °
				-121.985903 °	-121.985903 °
DWR ID	20407				
Comment Code					
Inspector Comment					
DS_ID:20407 FS_ID:54236 EP_NO: N/A Repair Type: Non-Urgent Crossing Status: Indicator Found UCIP Comments: 05/23/2019 Pipe not found. Confirm pipe removal or abandonment. (O.Yakimov - DWR UCIP) FIELD_STRUCT_DESC: 1 of 2: 7-inch oil pipeline of an unknown material through the levee, 2.6 feet below the crown. Metal support for pipe found at landside (LS) toe near Shell Oil Co. property edge. Appears to be abandoned. [Additional Reference(s): USACE Sacramento O&M Manual 131, May 1960 (HLM 49.22)]. FS Date: 5/23/2019 2:02:32 PM

Levee crown at crossing

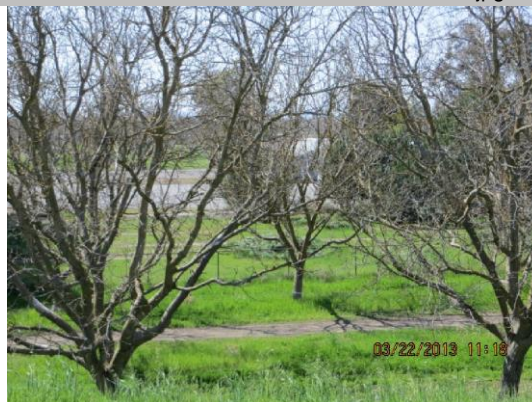
Photo 1 of 2 : UCIP_FA_2019_54237_17960.jpg

LM Start	48.77	Rating **	M	Issue No.	1686
LM End	48.77	Issue Type +	En	Location *	
Category	Supplemental			GPS Latitude/Longitude	
				Start	End
Item	DRAFT DWR UCIP Field Study			39.207919 °	39.207919 °
				-121.987343 °	-121.987343 °
DWR ID	20353				
Comment Code					
Inspector Comment					
DS_ID:20353 FS_ID:54237 EP_NO: N/A Repair Type: Non-Urgent Crossing Status: Not Found UCIP Comments: 05/23/2019 Crossing not found (O.Yakimov - DWR UCIP)03/22/2013 All four pipes appear to have been removed. FIELD_STRUCT_DESC: 1 of 4: 7-inch petroleum pipeline of an unknown material through the levee, 2.6 feet below the crown. Union Oil Co. dock. (Permit No. 1499, 1950 - Union Oil Company). [Additional Reference(s): USACE Sacramento O&M Manual 131, May 1960 (HLM 49.33)]. FS Date: 5/23/2019 2:37:16 PM

Shell yard off LS toe.

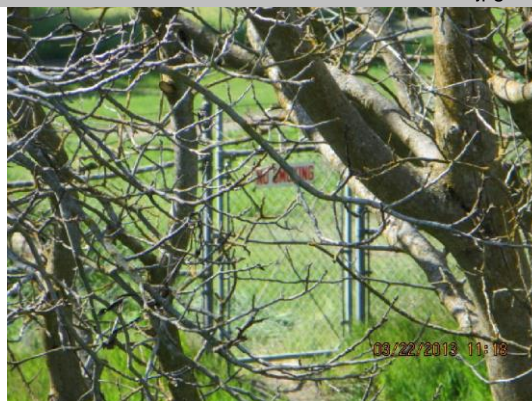
Photo 2 of 2 : UCIP_FA_2019_54237_17959.jpg

LM Start	48.77	Rating **	M	Issue No.	1686 (cont)	
LM End	48.77	Issue Type +	En	Location *		
Category	Supplemental			GPS Latitude/Longitude		
				Start	End	
Item	DRAFT DWR UCIP Field Study			39.207919 °	39.207919 °	
				-121.987343 °	-121.987343 °	
DWR ID	20353					
Comment Code						
Inspector Comment						
DS_ID:20353 FS_ID:54237 EP_NO: N/A Repair Type: Non-Urgent Crossing Status: Not Found UCIP Comments: 05/23/2019 Crossing not found (O.Yakimov - DWR UCIP)03/22/2013 All four pipes appear to have been removed. FIELD_STRUCT_DESC: 1 of 4: 7-inch petroleum pipeline of an unknown material through the levee, 2.6 feet below the crown. Union Oil Co. dock. (Permit No. 1499, 1950 - Union Oil Company). [Additional Reference(s): USACE Sacramento O&M Manual 131, May 1960 (HLM 49.33)]. FS Date: 5/23/2019 2:37:16 PM

Shell yard off LS toe.

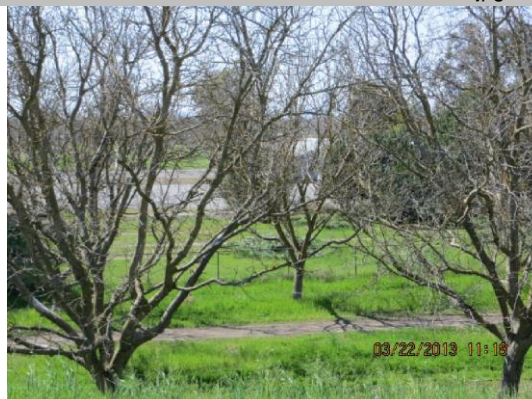
Photo 1 of 2 : UCIP_FA_2019_54238_17962.jpg

LM Start	48.77	Rating **	M	Issue No.	1687
LM End	48.77	Issue Type +	En	Location *	
Category	Supplemental			GPS Latitude/Longitude	
				Start	End
Item	DRAFT DWR UCIP Field Study			39.207926 °	39.207926 °
				-121.987359 °	-121.987359 °
DWR ID	20408				
Comment Code					
Inspector Comment					
DS_ID:20408 FS_ID:54238 EP_NO: 1499 Repair Type: Non-Urgent Crossing Status: Not Found UCIP Comments: 05/23/2019 Crossing not found (O.Yakimov - DWR UCIP)03/22/2013 All four pipes appear to have been removed. FIELD_STRUCT_DESC: 2 of 4: 7-inch petroleum pipeline of an unknown material through the levee, 2.6 feet below the crown. Union Oil Company dock. (Permit No. 1499, 1950 - Union Oil Company). [Additional Reference(s): USACE Sacramento O&M Manual 131, May 1960 (HLM 49.33)]. FS Date: 5/23/2019

Shell yard off LS toe.

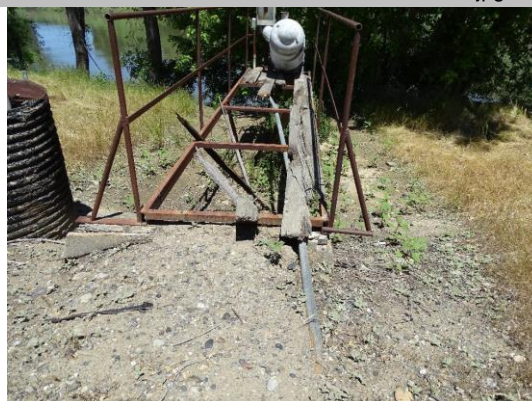
Photo 1 of 3 : UCIP_FA_2019_54244_79988.jpg

LM Start	49.39	Rating **	M	Issue No.	1693	
LM End	49.39	Issue Type +	En	Location *		
Category	Supplemental			GPS Latitude/Longitude		
				Start	End	
Item	DRAFT DWR UCIP Field Study			39.213191 °	39.213191 °	
				-121.996224 °	-121.996224 °	
DWR ID	20412					
Comment Code						
Inspector Comment						
DS_ID:20412						
FS_ID:54244						
EP_NO: 9334						
Repair Type: Non-Urgent						
Crossing Status: Found						
UCIP Comments: 05/23/2019 No issues recorded during inspection (O.Yakimov - DWR UCIP)						
FIELD_STRUCT_DESC: 1 of 2: 2-inch conduit of an unknown type and material through the levee, 18.5 feet below the crown. Meter pole at the landside (LS) toe. (Automatic Board Order (ABO) issued as Permit No. 9334, 1974 - Owner Unknown).						
FS Date: 5/23/2019 2:53:40 PM

Disrupted walkway to the pump with conduit visible

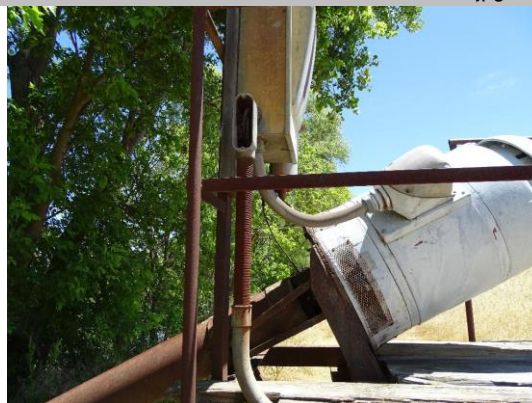
Photo 2 of 3 : UCIP_FA_2019_54244_79989.jpg

Conduit at slant pump

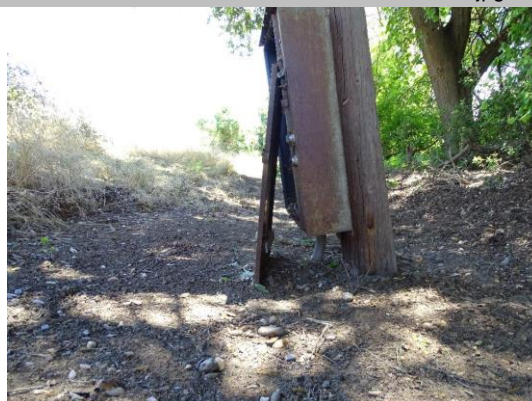
Photo 3 of 3 : UCIP_FA_2019_54244_79996.jpg

LM Start	49.39	Rating **	M	Issue No.	1693 (cont)	
LM End	49.39	Issue Type +	En	Location *		
Category	Supplemental			GPS Latitude/Longitude		
				Start	End	
Item	DRAFT DWR UCIP Field Study			39.213191 °	39.213191 °	
				-121.996224 °	-121.996224 °	
DWR ID	20412					
Comment Code						
Inspector Comment						
DS_ID:20412						
FS_ID:54244						
EP_NO: 9334						
Repair Type: Non-Urgent						
Crossing Status: Found						
UCIP Comments: 05/23/2019 No issues recorded during inspection (O.Yakimov - DWR UCIP)						
FIELD_STRUCT_DESC: 1 of 2: 2-inch conduit of an unknown type and material through the levee, 18.5 feet below the crown. Meter pole at the landside (LS) toe. (Automatic Board Order (ABO) issued as Permit No. 9334, 1974 - Owner Unknown).						
FS Date: 5/23/2019 2:53:40 PM

Conduit enters levee at LS toe

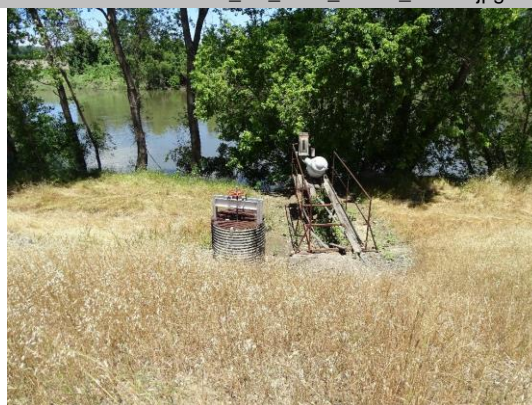
Photo 1 of 3 : UCIP_FA_2019_54245_79992.jpg

Comment Code					
Inspector Comment					
DS_ID:20301 FS_ID:54245 EP_NO: 9334 Repair Type: Non-Urgent Crossing Status: Found UCIP Comments: 05/23/2019 Pipe angles through the levee. Concrete box on LS found 30 feet upstream from pump on WS berm. No issues recorded during inspection (O.Yakimov - DWR UCIP) FIELD_STRUCT_DESC: 2 of 2: 36-inch corrugated metal irrigation pipe through the levee, 18.5 feet below the crown. Vertical pump unit on piling structure in the stream. Concrete pipe collar on the waterside (WS) end. Slide gate inside a 48-inch corrugated metal riser unit on the WS slope. Two corrugated metal cutoff walls. Timber walkway on the WS. Flap gate inside a concrete box on the landside (LS). Meter pole at the LS toe. (Automatic Board Order (ABO) issued as Permit No. 9334, 1974 - Owner Unknown). [Additional Reference(s): DWR Levee Log, 2006]. FS Date: 5/23/2019 2:28:12 PM

Pump and CMP riser on WS berm

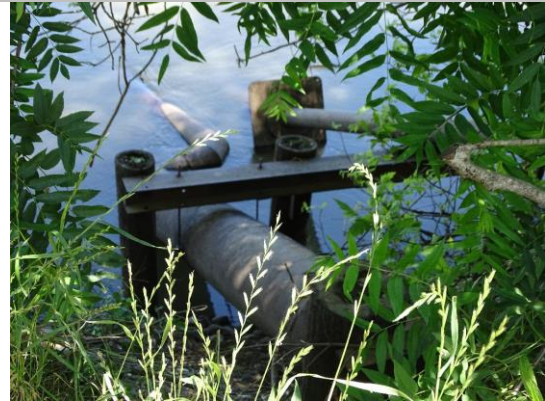
Photo 2 of 3 : UCIP_FA_2019_54245_79994.jpg

Pipes at riverbank

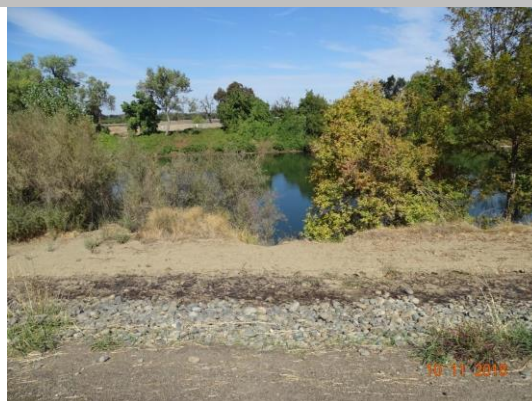
Photo 1 of 1 : FA_2019_NA0016_435_113_20190829_00047.jpg

LM Start	49.42	Rating **	A/W	Issue No.	113
LM End	49.42	Issue Type +	Ma	Location *	WS
Category	Earthen Levee			GPS Latitude/Longitude	
				Start	End
Item	Erosion / Bank Caving			39.213303 °	39.213303 °
				-121.996915 °	-121.996915 °
DWR ID	DWR_NA0016_01_f_2018_113				
Comment Code					
E1 : Note and monitor erosion site.					
Inspector Comment					
Runoff erosion is located on the waterside berm. Recommend monitoring.

View of erosion on the waterside berm. Fall 2018.

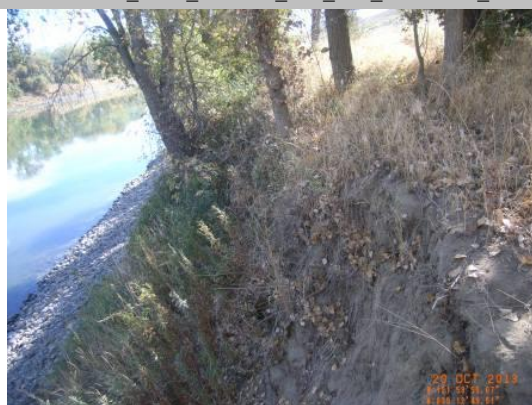
Photo 1 of 1 : FA_2019_NA0016_435_105_20190829_00039.jpg

LM Start	49.46	Rating **	A/W	Issue No.	105
LM End	49.57	Issue Type +	Ma	Location *	WS
Category	Supplemental			GPS Latitude/Longitude	
				Start	End
Item	2017 USACE Erosion Survey			39.213608 °	39.213869 °
				-121.997543 °	-121.999641 °
DWR ID	DWR_NA0016_01_f_2018_105				
Comment Code					
Inspector Comment					
2017 Site ID: SAC 143.5 R					
Status: Eroding					
2017 Field Notes: New erosion along lower slope.					
Site History: 2011 - Multiple scallops, one tree pop out. Old cobble site starting to unravel at midbank. 2012 - Mid bank slumping continues to worsen but cobble at the toe appears stable.

USACE 2013 Photo #1
